original layout

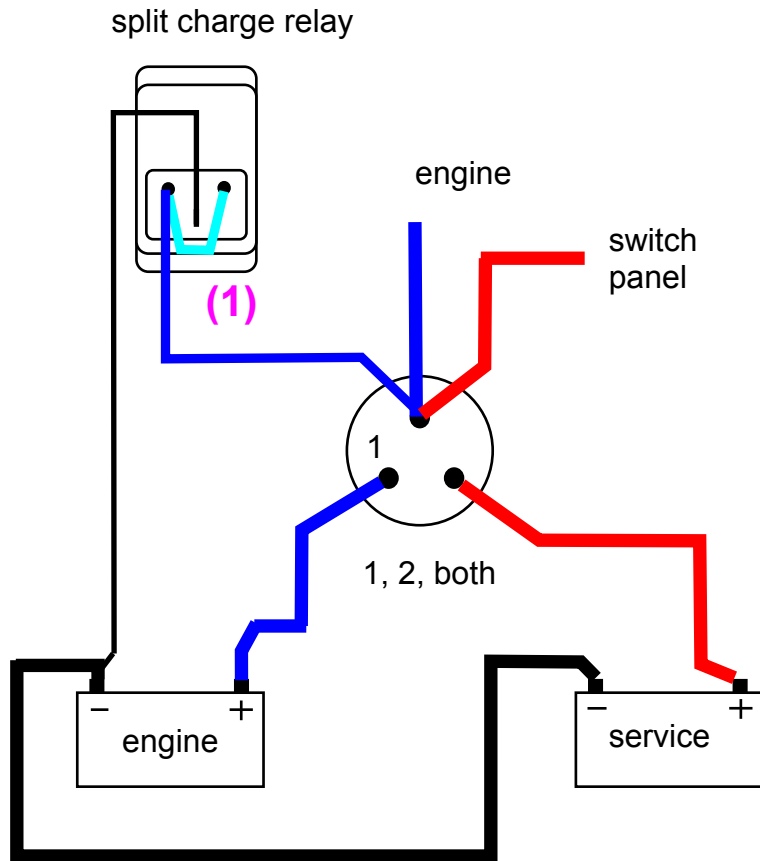
When built the boat should have been fitted with two isolator switches, one for engine supply, one for service power supply. A feed from each switch should have gone to the split charge relay, supplying feed to each voltage display and providing split charge.

Westerly fitted a 1,2 both switch in error and linked both terminals (1) on the split charge relay, This meant the split charge system did not work and the voltage display received incorrect voltage feed.

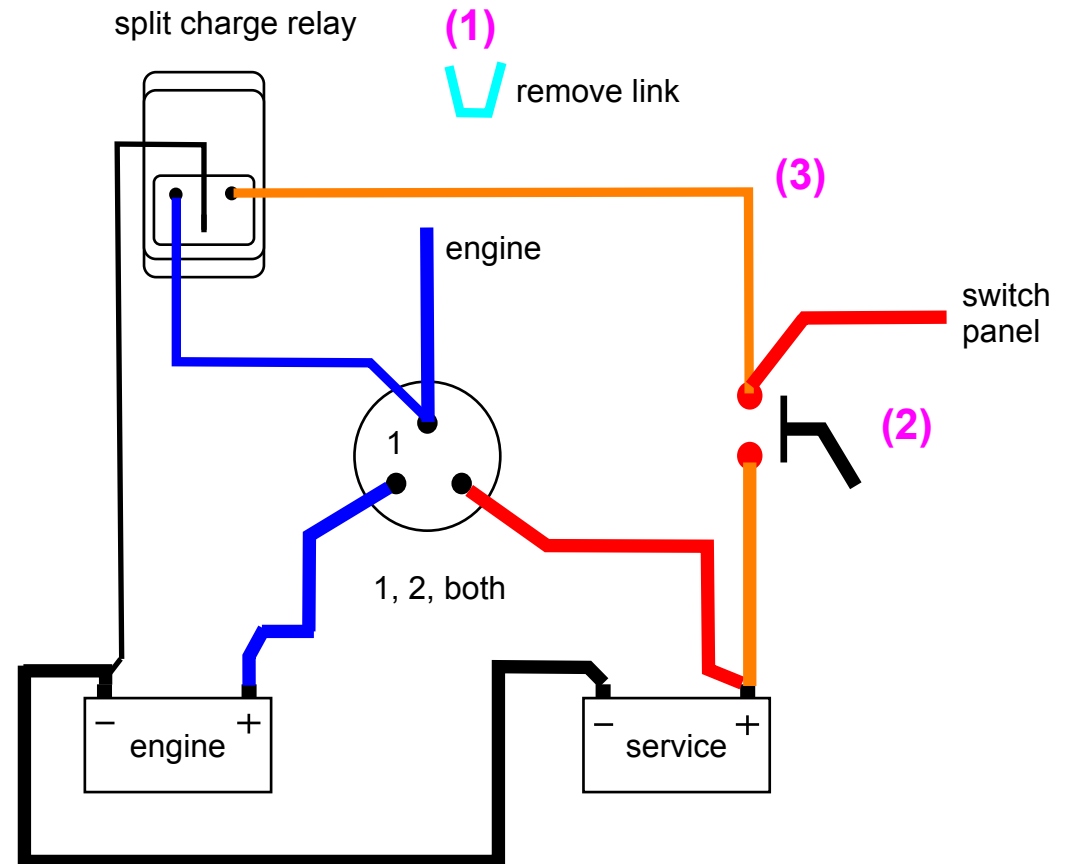
modified original layout

Position 1 feeds engine only

Position 2 allows links engine to service battery only.

Position both links all batteries for charge or starting.

To correct the installation fit a new isolator (2) and fit a new link cable between isolator and service battery positive, using suitable size cable. Transfer feed to service loads from the 1,2,both switch to the new isolator.

Remove link (1) from the split charge relay and fit a new charge cable (3) of suitable size.
